Subject: Re: Verifying Sealing on Concrete -Dearborn Animal Shelter (FFDAS)

Walkway Verification of Sealer Performance

Kennel Cage Verification of Sealer Performance

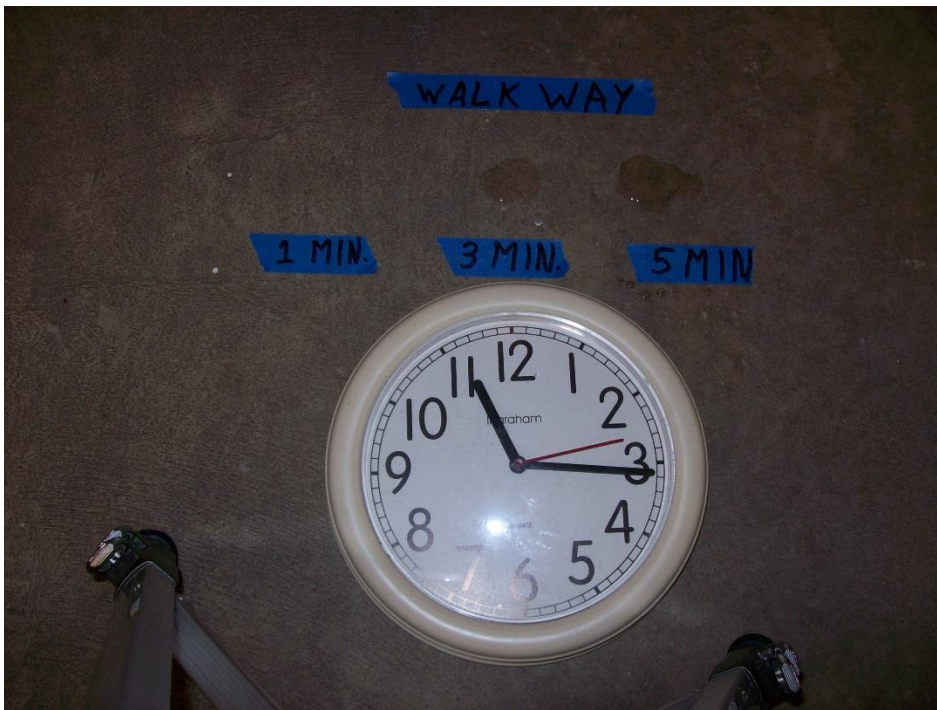
Photo #2

Water removed from concrete after one minute with cotton towel. Note no water penetration at 1 min location.

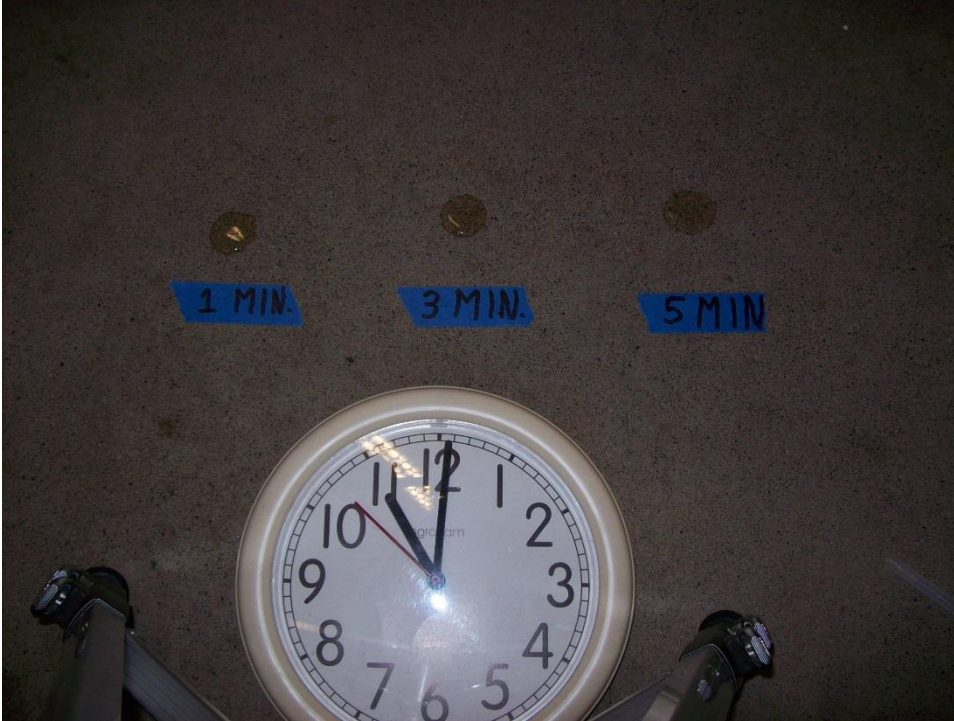
Photo #1

Start of test with three water puddles. Note water at all three locations of tape indicating time.

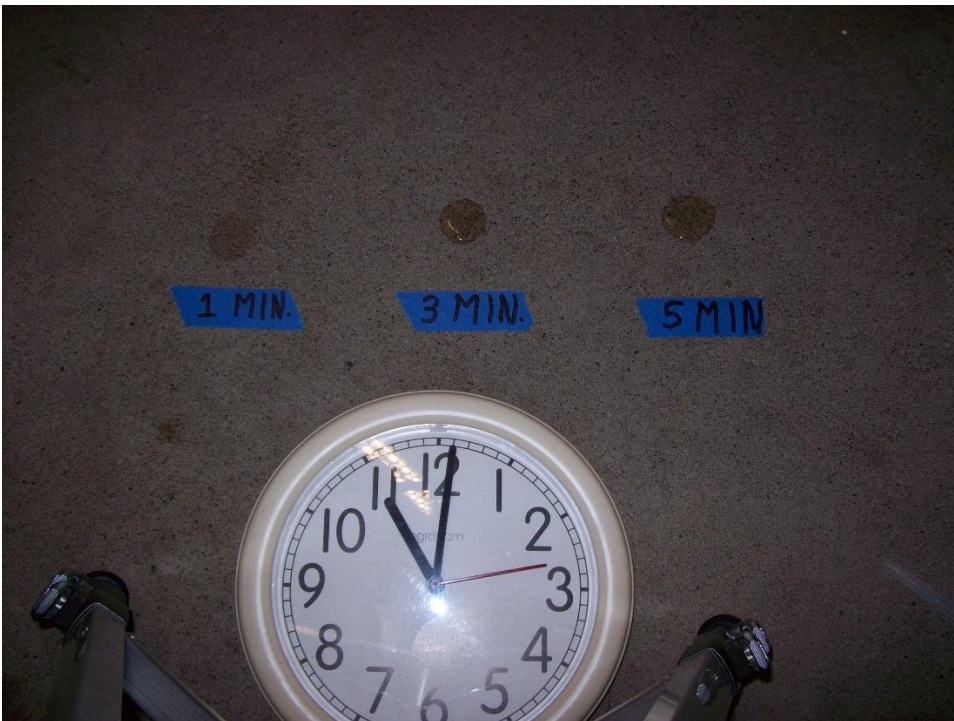
Photo #2

Water removed from concrete after one minute with cotton towel. Note no water penetration at 1 min location.

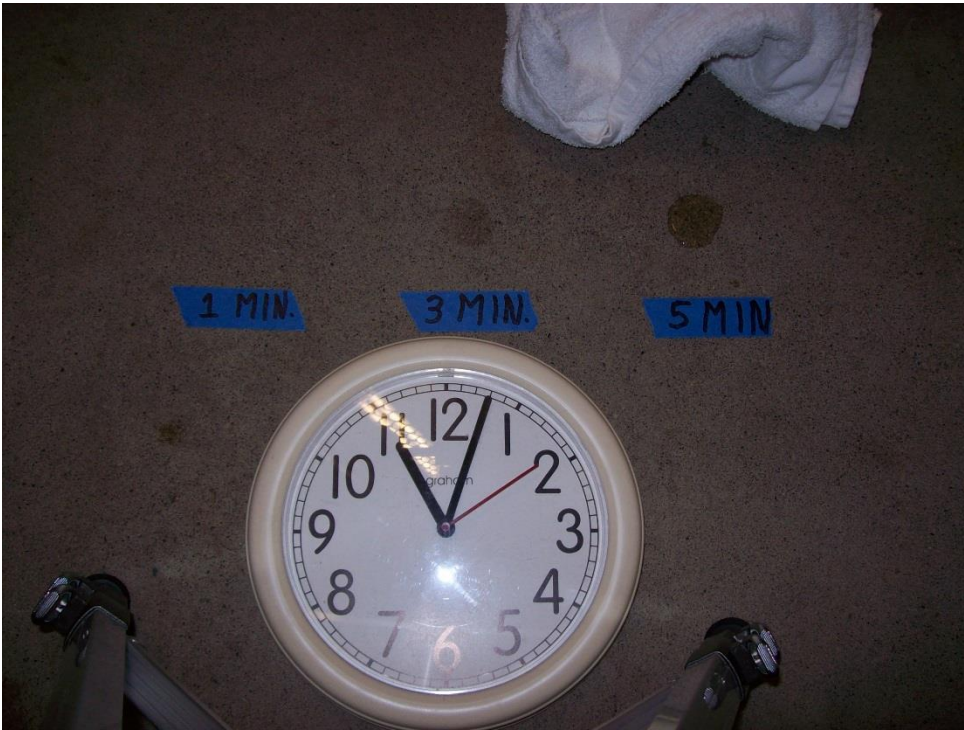
Photo #3

Water removed from concrete after three minutes. Note no water penetration at 3 min location and evaporation of surface moisture not picked up with cotton towel at 1 min location

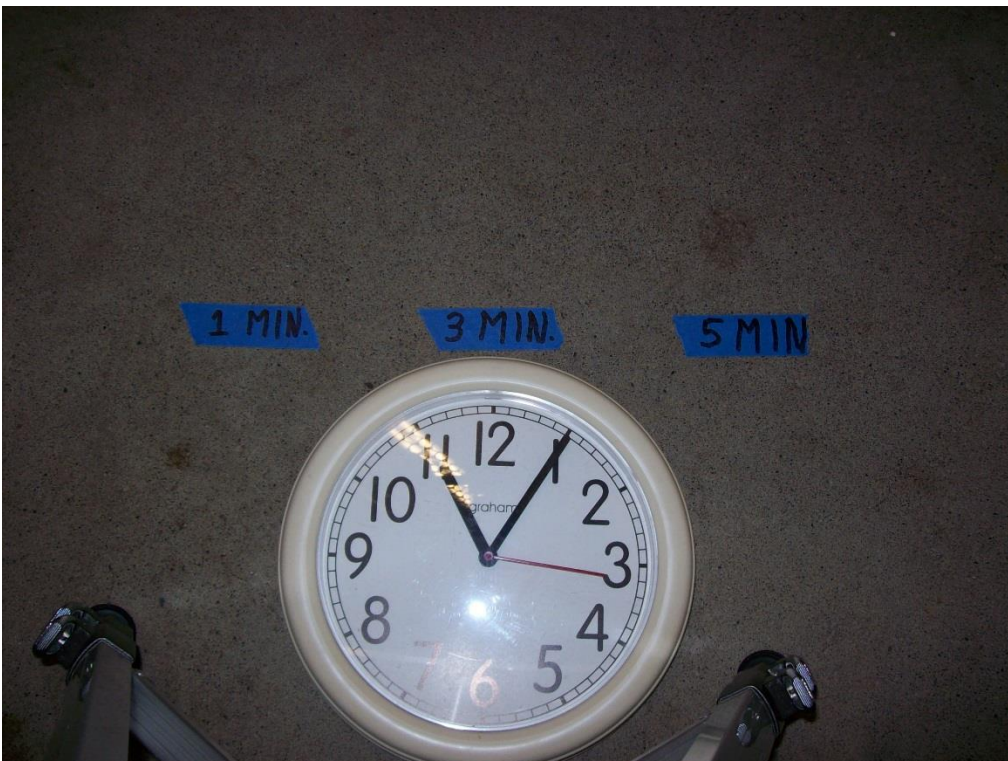
Photo #4

Water removed from concrete after five minutes. Note no water penetration at 5 min location and evaporation of surface moisture not picked up with cotton towel at 3 min location.

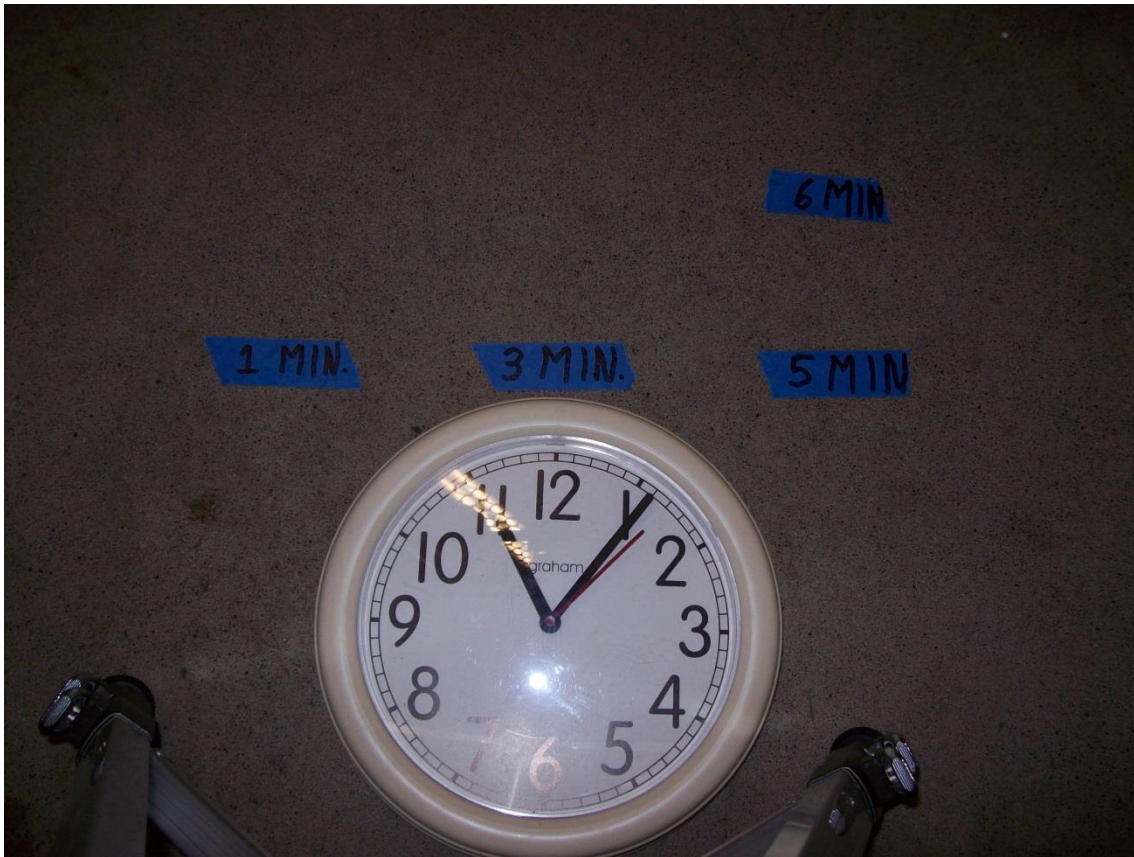
Photo #6

Note no water penetration at 5 min location and evaporation of surface moisture not picked up with cotton towel at 5 min location no change of surface condition after 6 minutes.

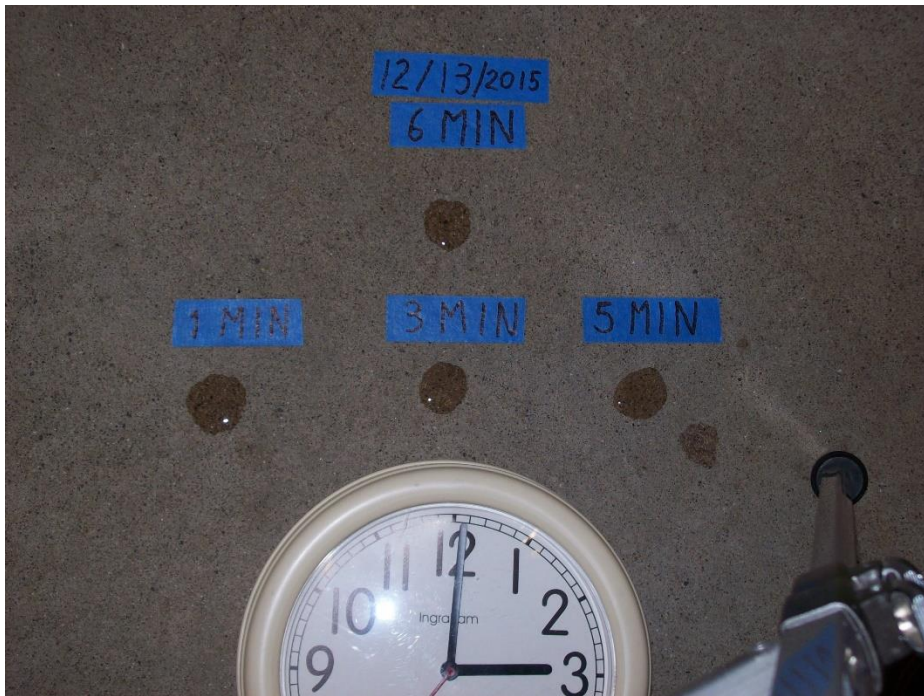
Photo #1

Start of test with four water puddles. Note water at all four locations of tape indicating time. Water in puddle is moving downward in the photo towards the drain – floor is NOT level.

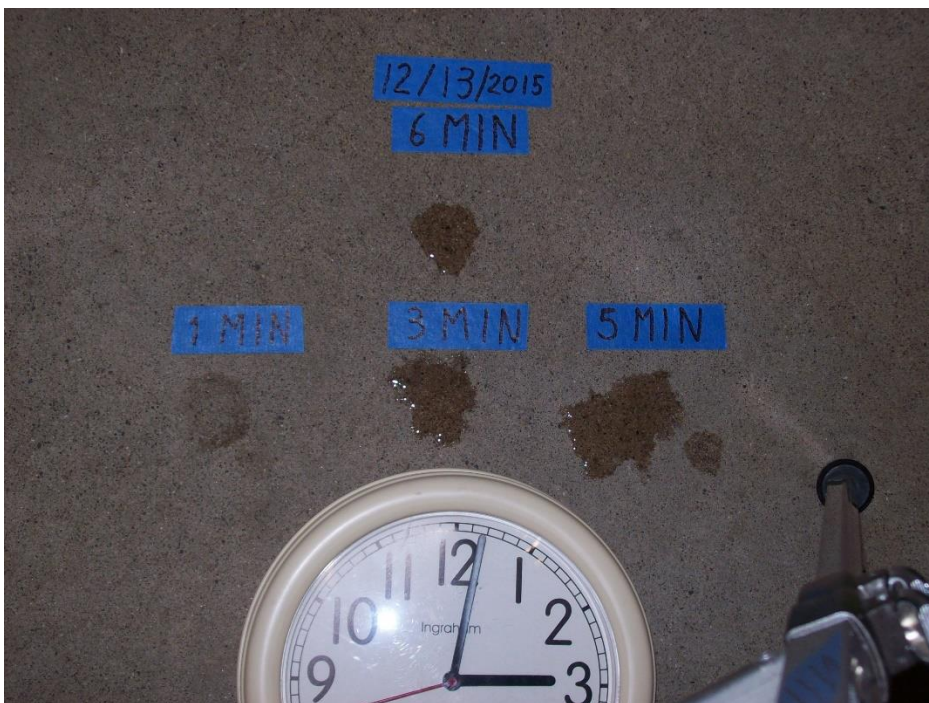
Photo #2

Water removed from concrete after one minute with cotton towel. Note no water penetration at 1 min location.

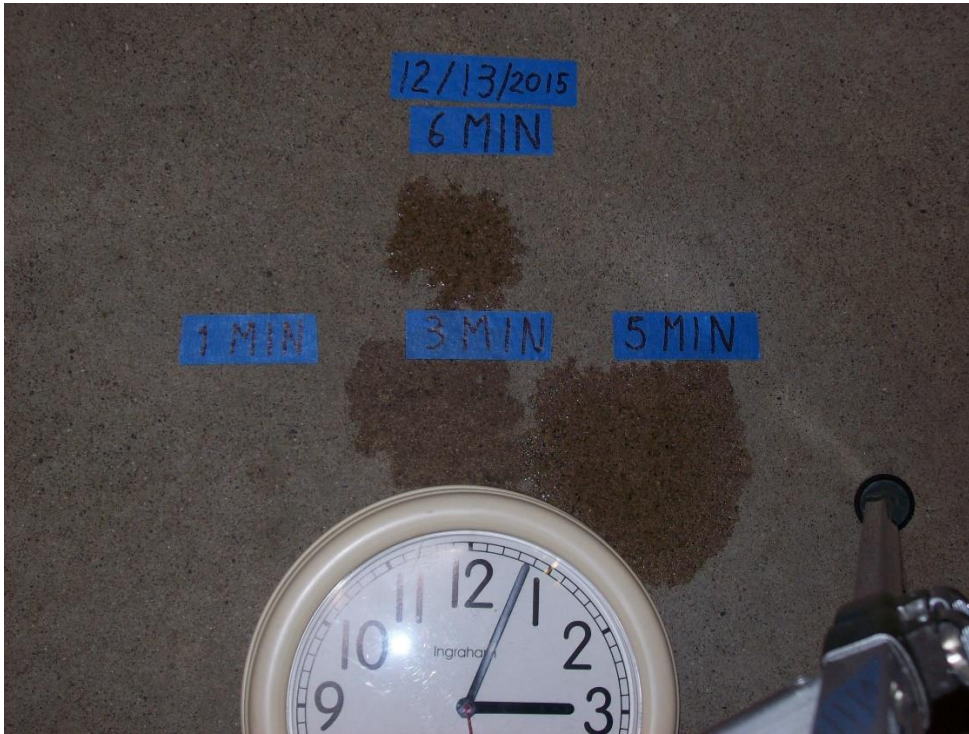
Photo #3

Water removed from concrete after three minutes with cotton towel. Note no water penetration at 3 min location and evaporation of surface moisture not picked up with cotton towel at 1 min location
